STREAMBANK PROTECTION GUIDELINES FOR LANDOWNERS AND  
LOCAL GOVERNMENTS(U) ARMY ENGINEER WATERWAYS EXPERIMENT  
STATION VICKSBURG MS ENVIRONMENTAL LAB M P KEOWN

# Streambank Protection Guidelines

...For Landowners  
and Local Governments

Prepared by: U.S. Army Engineer  
Waterways Experiment Station,  
Vicksburg, Mississippi 39180

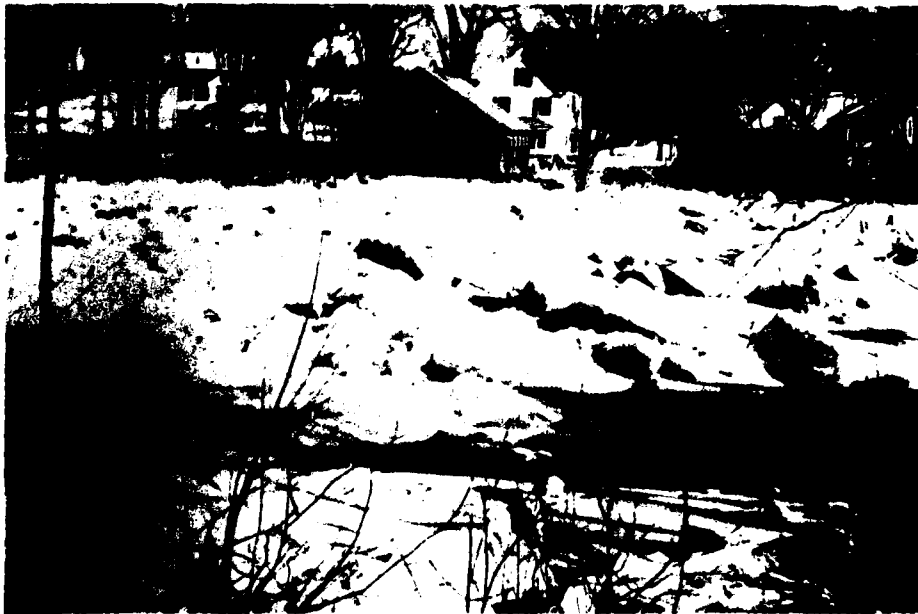
*Debris can cause streambank erosion due to abrasion or impact.*

to the streambanks is largely determined by whether the banks are still frozen or have begun to thaw. Frozen banks generally sustain little soil loss; however, structures such as boat docks, as well as trees and other vegetation, may be stripped away from the frozen banks by the impact of the ice chunks or pressure buildup from an ice jam. If the chunks of pack ice pass through a channel where the banks have already thawed, severe bank erosion can occur, mainly due to grinding of the ice against the streambank (abrasion). Debris, like ice, can cause streambank erosion by either abrasion or impact. The most common debris found in streams are the remains of fallen trees.

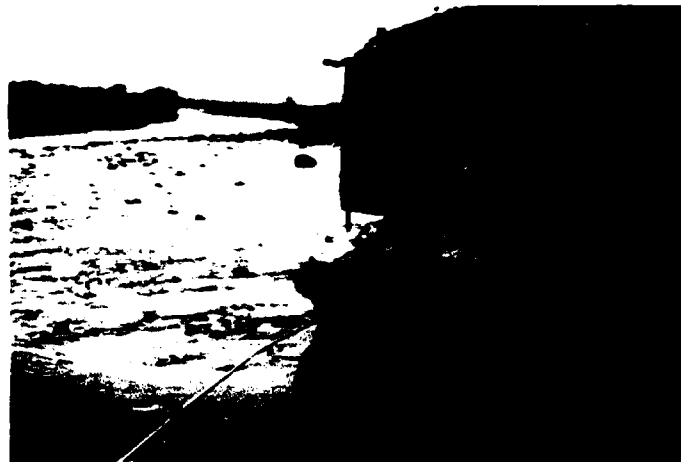
*Clearing of a greenbelt adjacent to the top of a streambank often leads to severe erosion. Note natural greenbelt in background.*

- a. Greenbelts should not be clearcut to top bank to provide more land for cultivation or to provide a better view. The greenbelt prevents overuse of the top bank area by man, animals, and machinery. The belt also retards rainfall runoff down the bank slope and provides a root system that binds soil particles together.

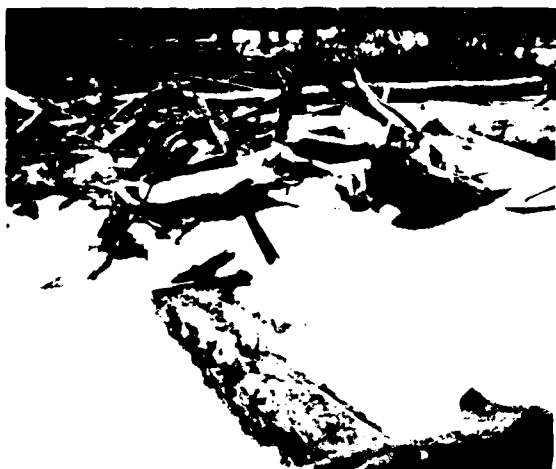
*Bank erosion may occur as a stream attempts to flank a log jam.*

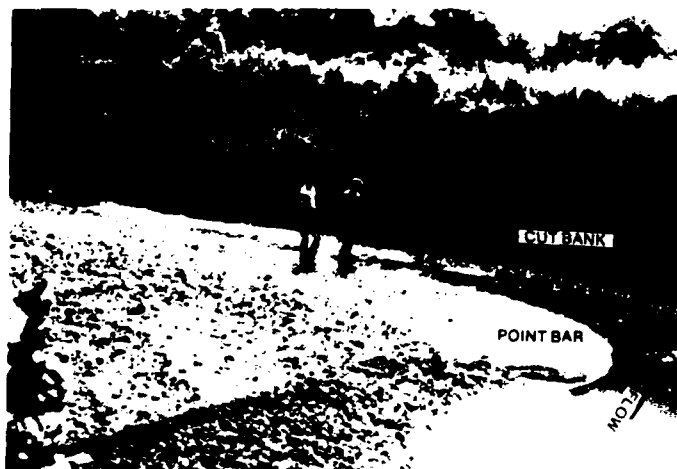
*Point bar deflects stream current against cut bank.*

Because of the large volume of sand and gravel involved, the landowner or local government probably cannot remove a mid-channel bar or point bar. The alternative is to let the stream do the work by using the following procedures. If there are tall trees growing on the bar, they should be removed with a tractor and a block and tackle, if necessary. Always remove as much of each tree's root mass as possible. The extensive root system of large trees hold the sand and gravel in place on the bar. If the tree is too large to pull out, cut it down at ground level. Smaller shrubs need not be removed at first since their root systems are usually shallow.

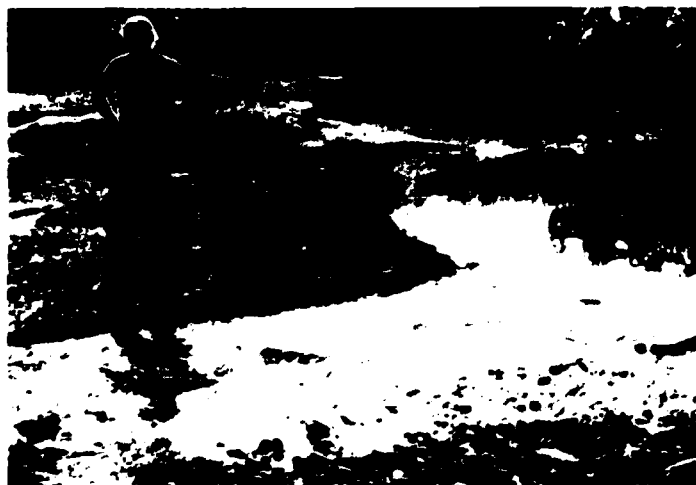
*Pilot channel eroding point bar (left). Concrete check dam (right).*

If later observations indicate that the shrubs are preventing the bar from eroding, then they will have to be removed. Next, dig one or more pilot channels through the bar. The pilot channels can be dug with hand tools if trenching equipment is not available or if the bar is not accessible to machinery. Locate the channels at such an angle that a rapid current is diverted into the trench. This rapid current is needed to erode the bar. If the bar is large, several pilot channels may have to be dug. Any large stones or leaf debris should be raked off the sides of the bar. This will increase the current flow along the edges of the bar and promote erosion. If the bar is not removed by flow through the pilot channels, a current deflector can be used. The deflector consists of a brush pile or fallen tree secured at a point upstream from the bar. The current deflector should be positioned to divert the

A check dam should be placed bank to bank across the scouring channel bed and located downstream from the rough water or waterfall. (NOTE: Check dams can also be placed upstream from the waterfall or rough water to intercept the headcut; however, this solution should not be considered without the benefit of professional assistance.) The net effect will be to reduce the stream velocity and to encourage sediment deposition which will build up the scoured bed. Check dams can be constructed from stone, concrete, sand-cement bags, treated timber, metal, etc. The toe of the check dam should be well protected to prevent the structure from being undermined. Further, the ends of the dam should be rooted into the banks so the structure cannot be flanked. Streambanks immediately downstream from a check dam sometimes show a tendency to erode. These banks should be watched after the dam is completed. Check dam construction can be very expensive;

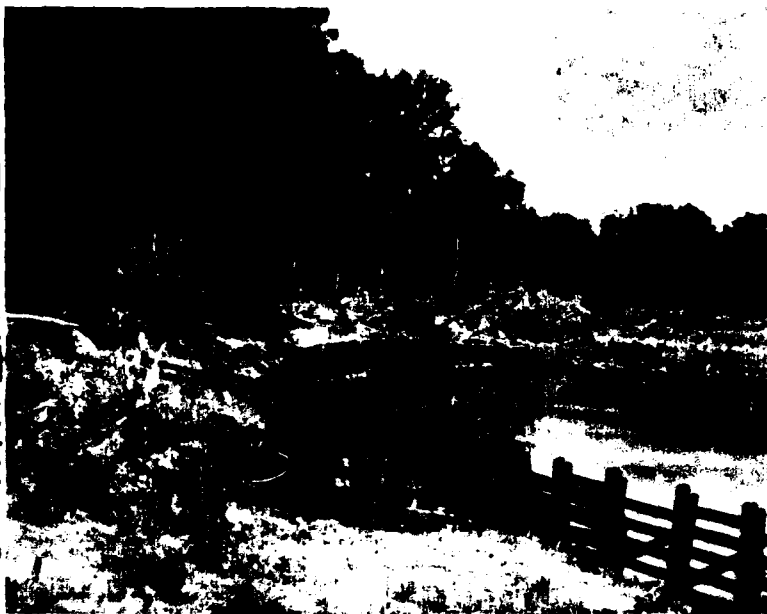
*Wooden fence constructed along eroding streambanks. Note sediment deposition behind the fenceline and the tie-back fences between the fence and bank (left). Double row fence (right). Fences are most successful as a bank protection method on streams with heavy sediment loads.*

Many types of local materials have been used for fence construction. Wood, used rails, pipe, steel beams, etc., are suitable as fence posts. The same materials can be used to back brace the fence. Wood and wire are generally used for the fencing material. If wire is used it should be strong enough to withstand the expected current load of water and debris. Field fencing and welded-wire fencing are effective against heavy and medium current loads, while chicken wire is suitable for lighter loads. Double row fences are sometimes constructed to provide additional resistance to stream attack with the gap between the fences filled with brush, hay, stone, or used tires.

- b. The ends of the fence should be tied into the bank at the upstream and downstream ends of the fenceline to minimize flow between the fenceline and the bank that could cause erosion. If the fence is long, tiebacks are needed at regular intervals between the fenceline and bank.

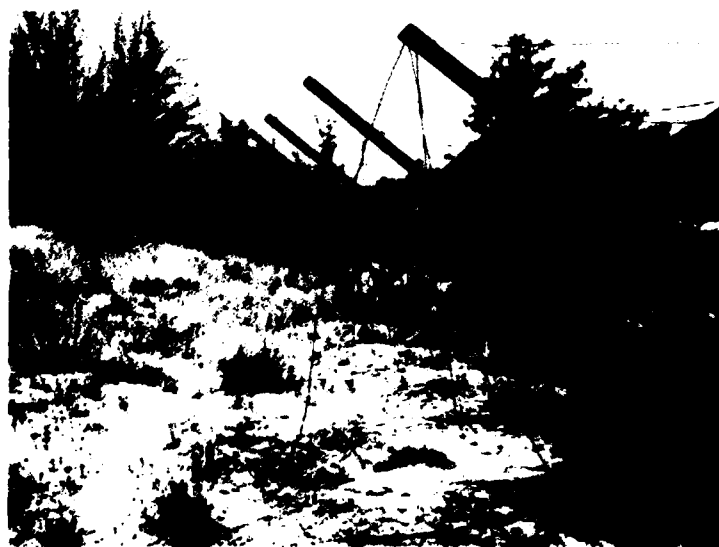
*Kellner jacks assembled from angle iron.*

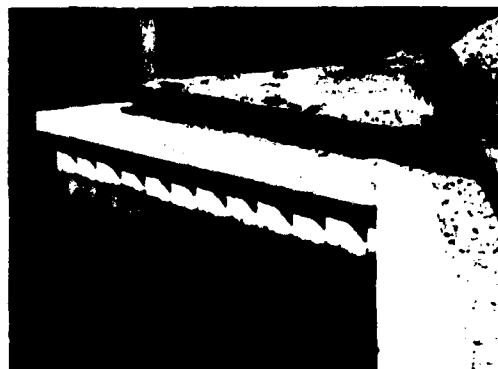
**RIGHT:** Asbestos fiber bulkhead with a concrete cap serves as a boat dock and stabilizes the bank.

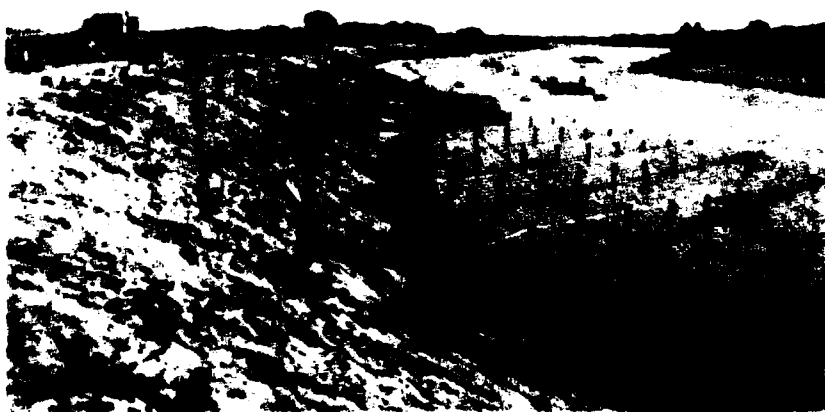
*BELOW: Wire fence dike field. Note that the top of each fence post is guyed to the bottom of the fence post immediately upstream and that each fence line is tied into the bank.*
